Brule River: Water Temperature Monitoring Report

7/1/2014 – 6/20/2015

In efforts to diligently protect and preserve the Brule River, Brule River Preservation elected to pursue water temperature monitoring as a means to keep watch over the river. Northflow LLC was contracted to install, upkeep, and collect data from these monitors. In this report, the results of one year of temperature monitoring will be discussed and analyzed.

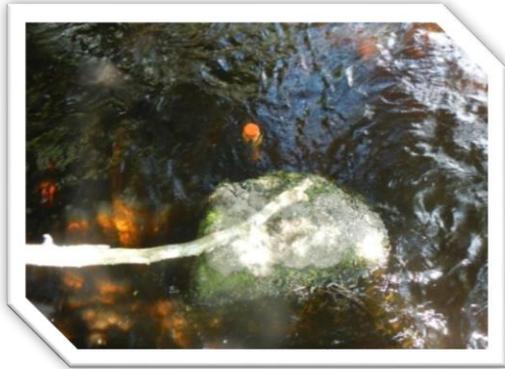
Site 1: Cedar Island Conservancy

Located below the bridge on the Cedar Island Conservancy property, this monitor is attached to the bottom of the river with a cable and housed in custom fit PVC housing. This site is located upstream in relation to the majority of the other monitors, and is located in a well forested portion of the river. The substrate near this site is rocky and sandy.

September 24, 2014 | Cedar Island monitor (Site 1), Big Lake monitor (Site 2), and Winneboujou Bridge monitor (Site 5) were originally installed with just a rebar stake and a custom PVC house was attached with zip ties and clamps to it. These three sites were updated to use a steel cable as a means of attaching the PVC house to the rebar. This will assist in fluctuating water levels.

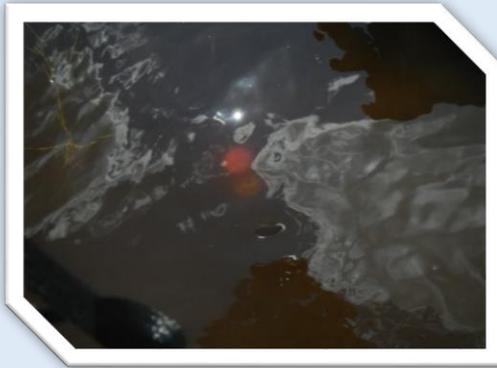
Site 2: Big Lake

This site is in a large pool of the Brule River, where the river opens up and is slower moving. This monitor is attached to the bottom of the lake with rebar, cabling, and a custom fit PVC housing unit. This location has very sandy substrate, and sits near large rocks on the east side of the river.

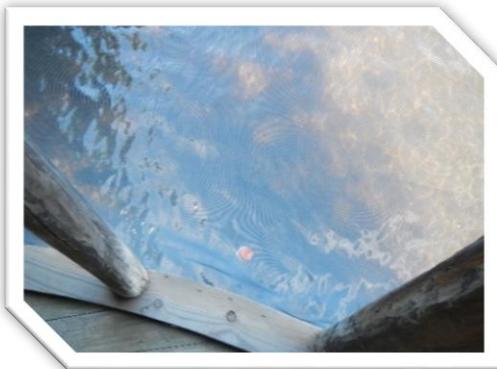
Site 3: Upper Lucius Lake

As pictured, the monitor sits just outside of Wildcat Camp on Upper Lucius Lake. Just across the river from this monitor is a site of sediment accumulation. The unit is attached to a rebar stake and housed inside a custom PVC case. The substrate here is very mucky and black.

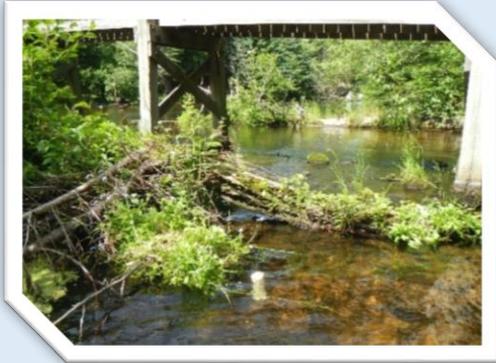
Site 4: Downstream Lucius Lake

Immediately downstream of Site 3, this monitor sits just below Castle's foot Bridge. The substrate here is rocky and silty, and the monitor itself is protected by nearby vegetation (as shown in the photo). The monitor is installed with a rebar stake and housed inside a custom PVC case.

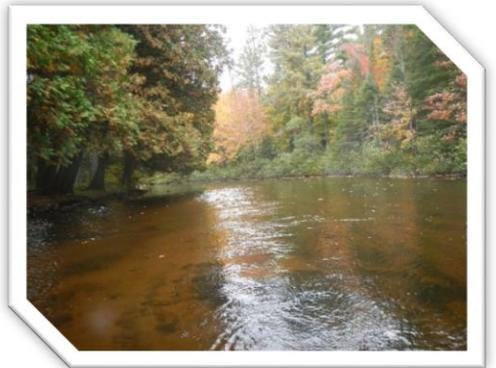
Site 5: Winneboujou Bridge

The monitor at Site 5 is located inside a run of the river, indicating fast flowing water. Attached to a rebar stake and housed within a custom PVC case, it is located directly below the Winneboujou Bridge. The substrate at this location is very sandy, and this portion of the river is well shaded and free of debris.

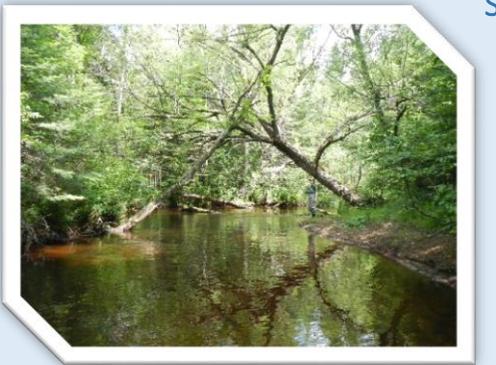
Site 6: Nebagamon Creek

A tributary to the Brule River, Nebagamon Creek holds a high sediment load. Within the extremely silty, mucky substrate, the monitor is housed in a custom PVC case and attached to a rebar stake. This creek has lots of fallen logs and branches within it.

June 18, 2015 | Monitors at Nebagamon Creek (Site 6) and Castle's Road Culvert (Site 9) were buried in 6+'' of fine sediment. During data collection they were unburied and reattached to rebar stakes. These monitors should be either moved to nearby locations with less sedimentation or consistently checked on to unbury and reattach.

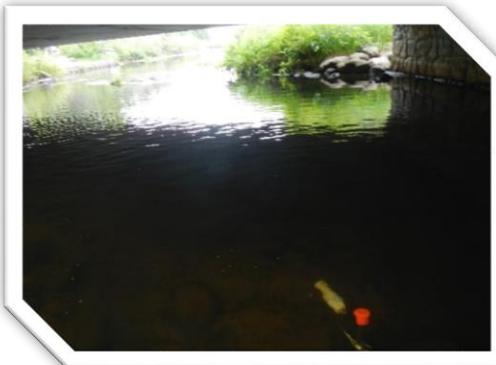
Site 7: Stone's Bridge Canoe Landing

As shown in the photo, this monitor is under Stone's Bridge, just upstream of the canoe landing. The river is very large and slow moving here. This location is free of vegetation and sits within a very rocky substrate. A rebar stake holds the custom PVC housing unit with a steel cable.

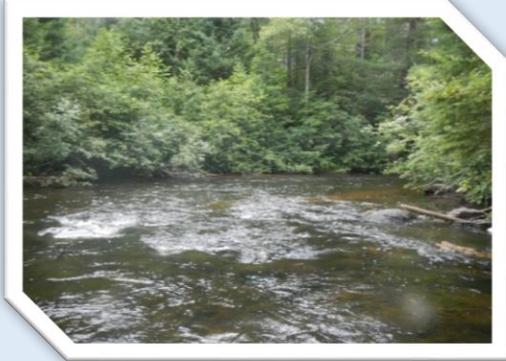
Site 8: Brule Ranger Station

This location is within a bend of the Brule River where water is very fast moving. The monitor is attached to sandy/rocky substrate with a rebar stake which holds the unit in a custom PVC house with a steel cable. Some erosion is noticeable on the east bank near the monitor. Lots of overhanging vegetation is present, as well as invasive species along the banks.

June 18, 2015 | During data collection at the Brule Ranger Station (Site 8), the steel cable connecting the PVC housed monitor to the rebar stake anchoring it to the river bottom was found completely cut. It did not appear to look as though vandalism had occurred. This site is located in fast water near a bend in the river which may increase the stress of the cable relative to other sites. The cable was replaced immediately and should be persistently monitored in order to ensure the cable is not cut again.

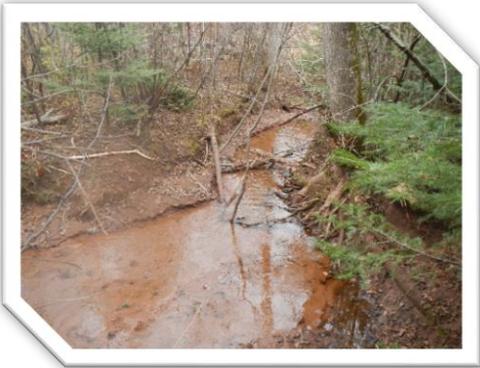
Site 9: Castle's Road Culvert

Cutler Creek, a tributary to the Brule River, runs through the culvert of Castle Road. Site 9 is located downstream of Castle Road. A narrow, sinuous stream of water bends through well wooded land. The monitor is attached with a rebar stake, PVC housing, and a steel cable. The substrate is very mucky and soft.

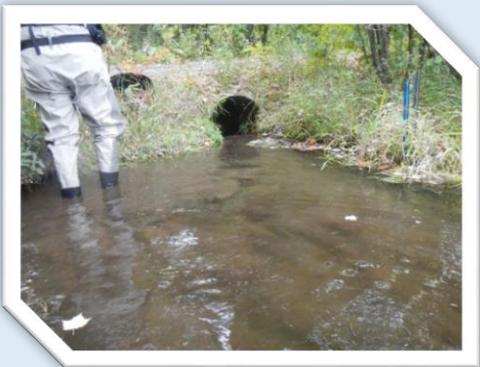
Site 10: Jack's Lake

Site 10 is located on Jack's Lake off of Nedadgewon Road. Jack's lake is very open, and the water moves slowly through it. The monitor is located near a blue post, and is installed with a rebar stake and a custom PVC case. The substrate is very fine, mucky, and soft.

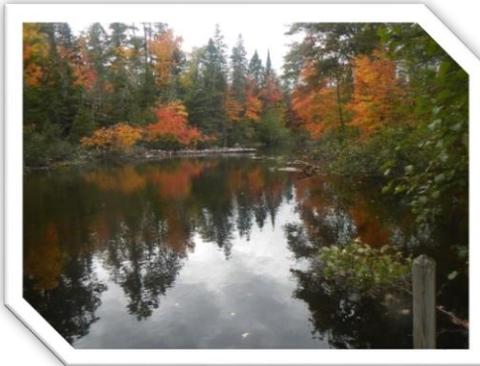
Site 11: Noyes Camp Dock

Located within a large bend in the Brule River, Site 11 is located off of a private dock at Noyes Camp. Both a water temperature monitor and water level monitor are installed at this site. The substrate is very rocky here, and the water is generally open and free of hanging vegetation.

Site Location | The monitor at Noyes' Camp (Site 11) has recorded extreme daily temperature fluctuation (especially in the first few months of deployment). The water level logger at this location also has recorded extremely varying data. This monitor should potentially be relocated somewhere deeper in the river.

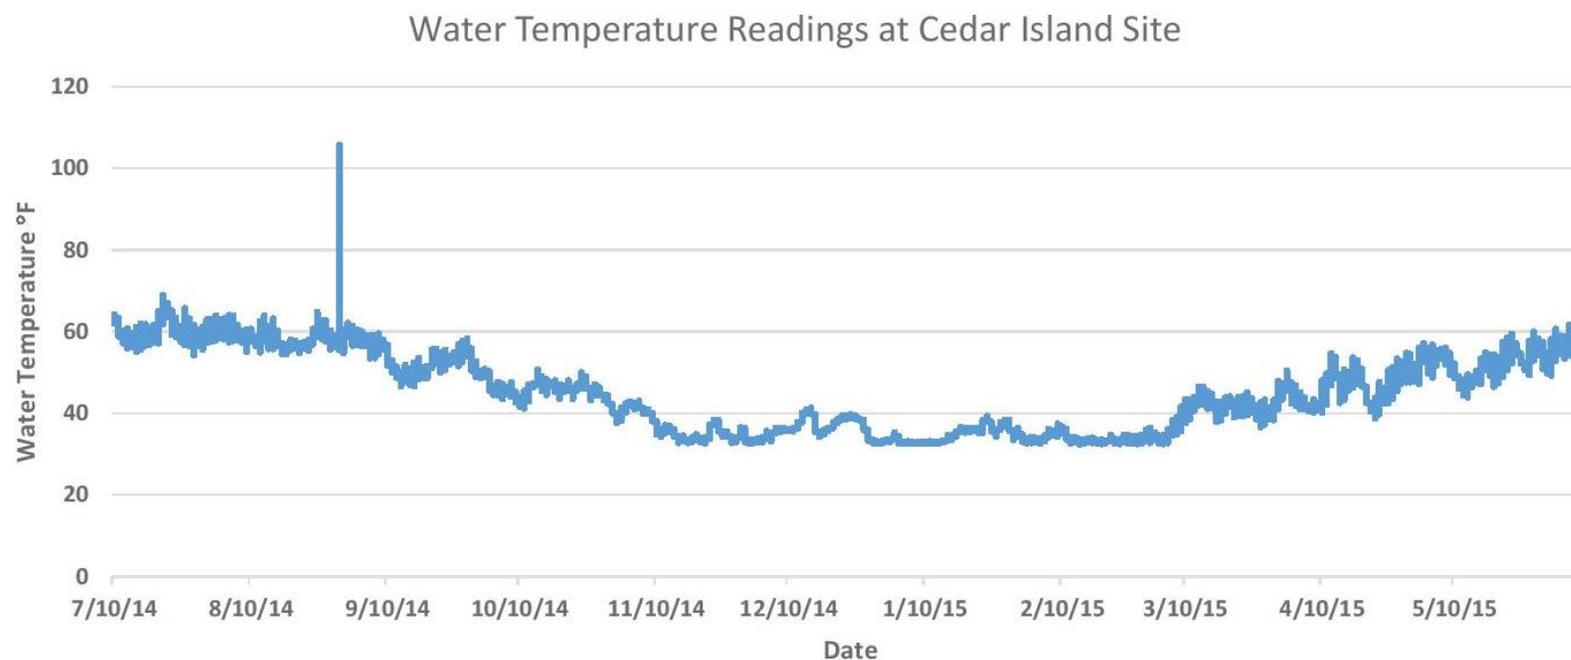
Site 1: Cedar Island Conservancy

A large spike occurs for 4 consecutive recording intervals beginning at 2:30 AM on August 8th, 2014. Immediately following the spike of temperatures over 100° F, the monitor resumes recording normal temperatures of about 56° F.

Statistical Summary of Cedar Island Site	
Maximum Temperature	68.871 °F
Average Temperature	45.177 °F
Minimum Temperature	32.443 °F
Number of Observations	16,056

Outliers | Upon review of operating manual for the HOBO Water Temperature Pro v2 Data Logger there are no anticipated explanations for unusual temperature spikes recorded by the monitors. Only 3 sites showed significant outliers, but this should be watched in future monitoring efforts. If outliers begin appearing more frequently, contact to Onset© should be made.

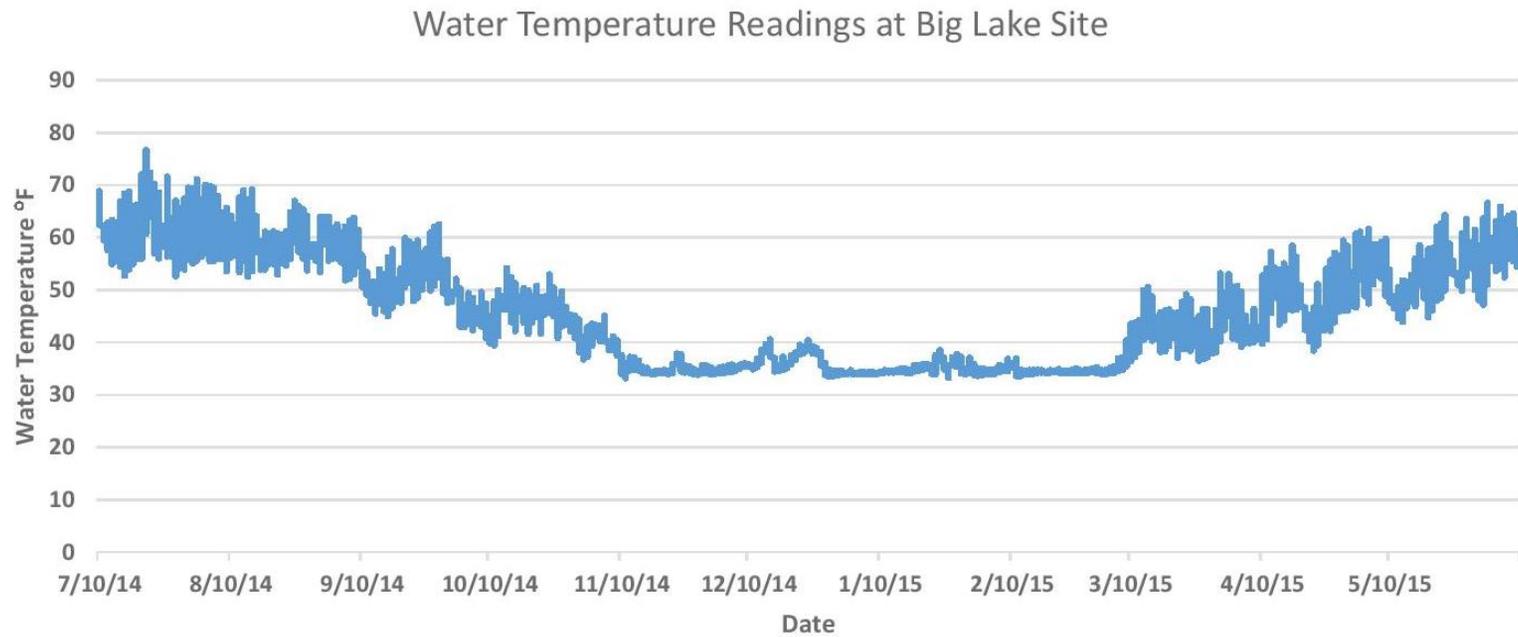
Site 2: Big Lake

There are no significant outliers at Site 2.

Statistical Summary of Big Lake Site	
Maximum Temperature	76.593 °F
Average Temperature	45.680 °F
Minimum Temperature	33.237 °F
Number of Observations	16,035

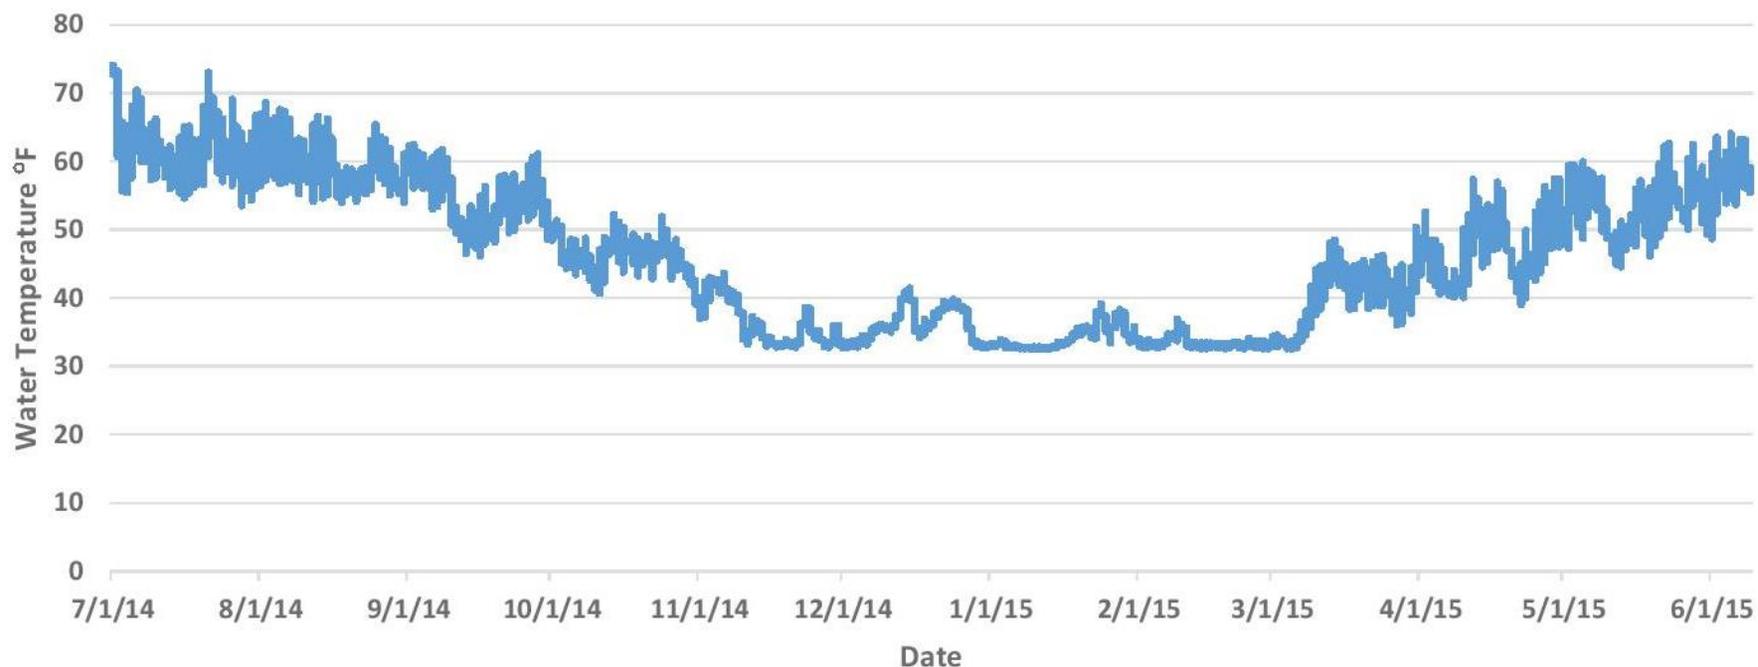
Water Temperature Readings at Upper Lucius Lake Site

There are no significant outliers found in the data at Site 3.

Statistical Summary of Upper Lucius Lake Site	
Maximum Temperature	72.995 °F
Average Temperature	45.833 °F
Minimum Temperature	35.542 °F
Number of Observations	16,418

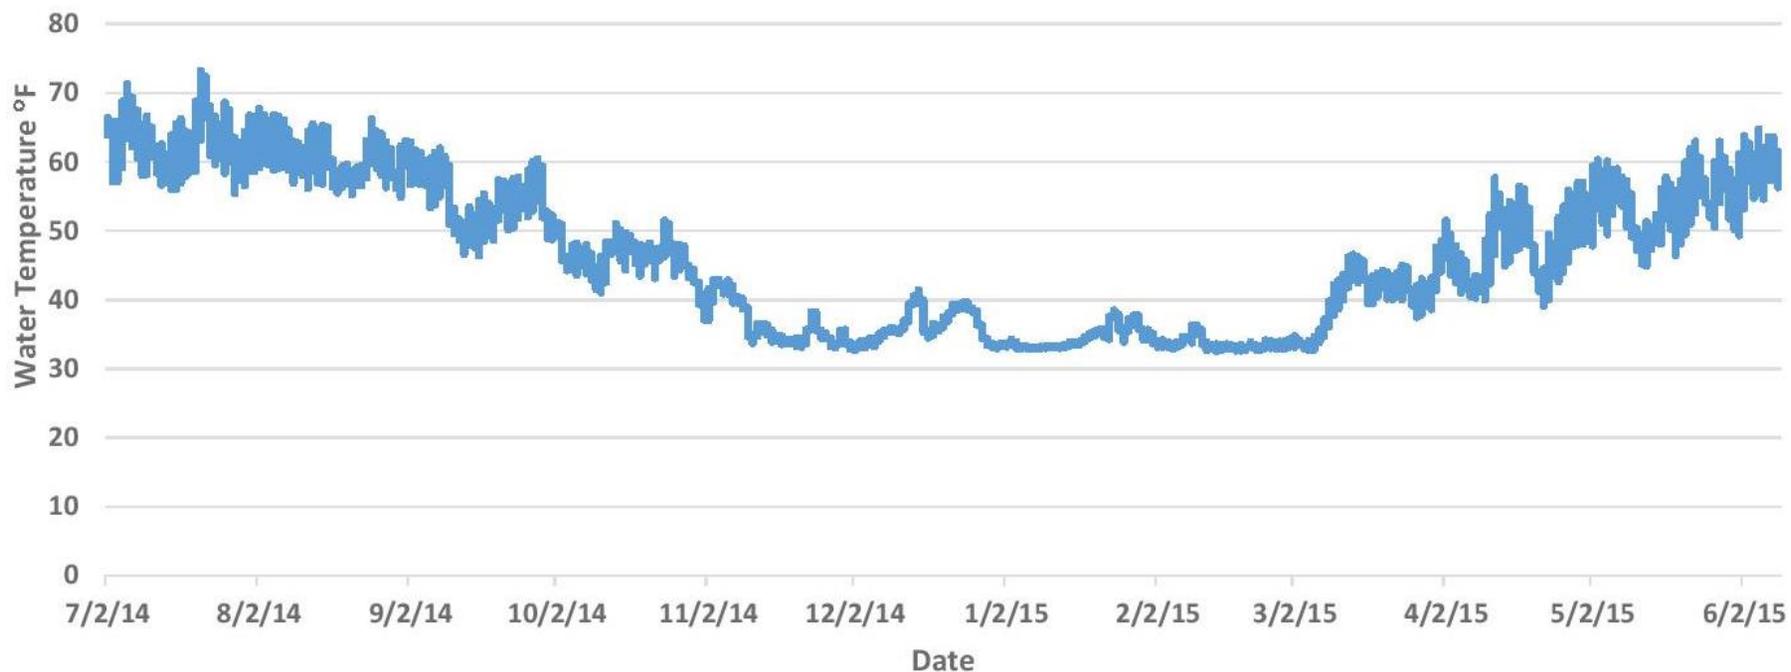
Water Temperature Readings at Downstream Lucius Lake Site

There are no significant outliers found in the data at Site 4.

Statistical Summary of Downstream Lucius Lake Site	
Maximum Temperature	73.213 °F
Average Temperature	46.317 °F
Minimum Temperature	32.592 °F
Number of Observations	16,414

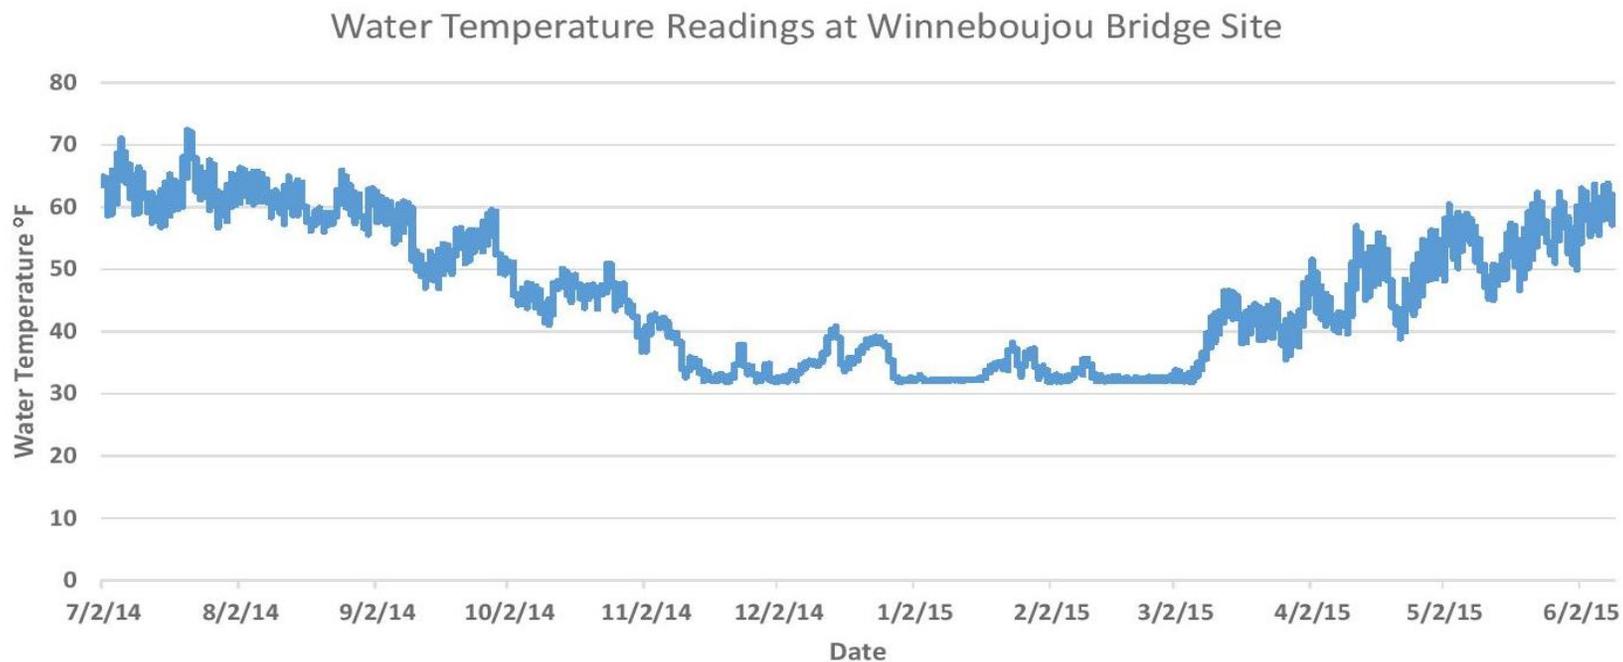
Site 5: Winneboujou Bridge

There are no significant outliers for Site 5.

Statistical Summary of Winneboujou Bridge Site	
Maximum Temperature	72.307°F
Average Temperature	46.115 °F
Minimum Temperature	31.993 °F
Number of Observations	16,418

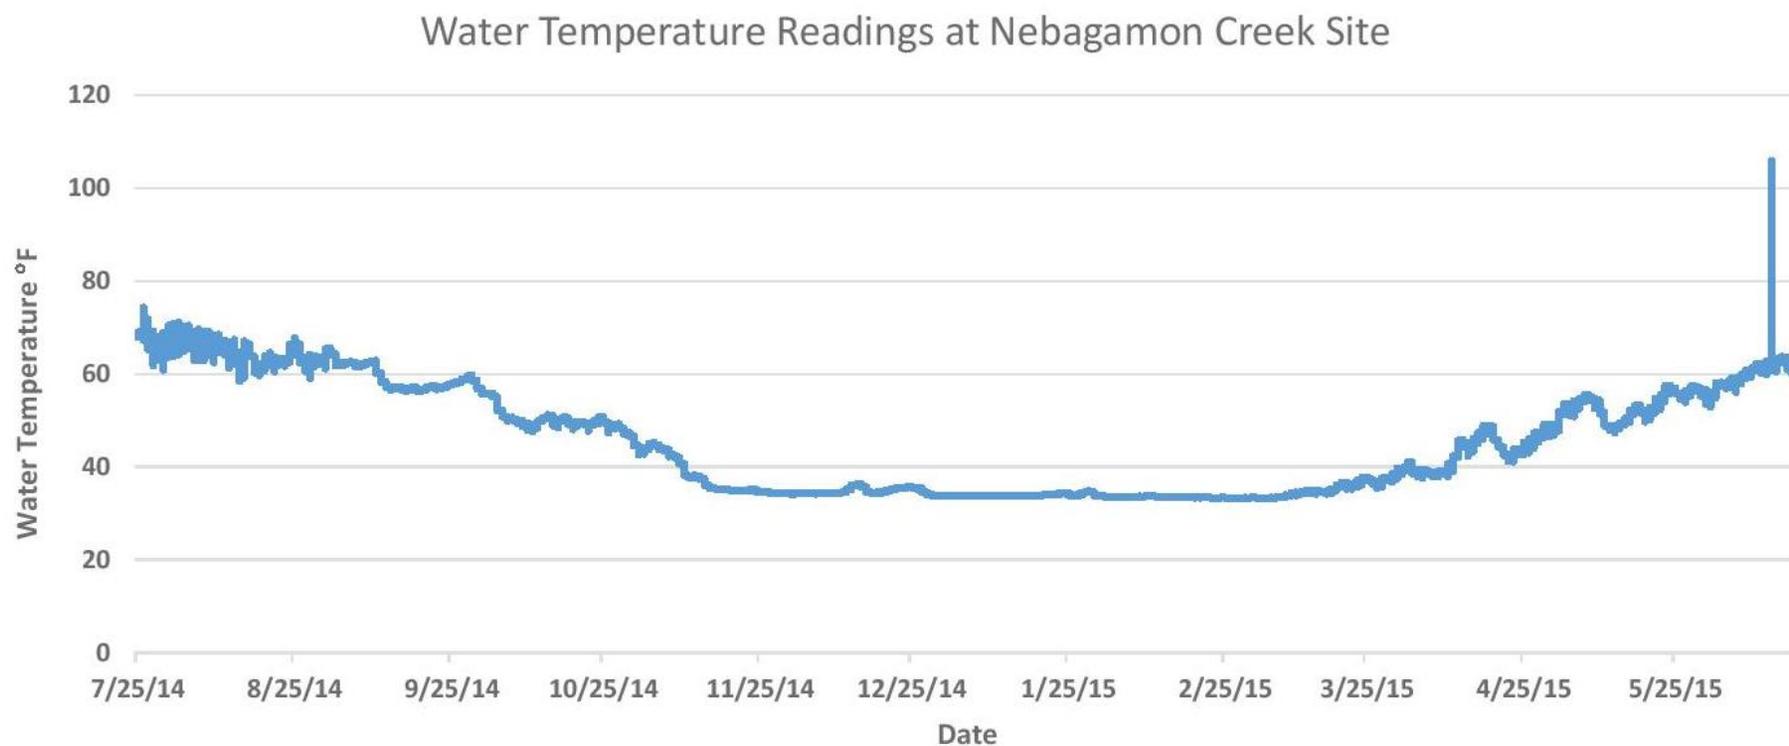
Site 6: Nebagamon Creek

A large spike occurs for 3 consecutive recording intervals beginning at 6:35 PM on June 13th, 2015. Immediately following the spike of temperatures over 100° F, the monitor resumes recording normal temperatures of about 61° F.

Statistical Summary of Nebagamon Creek Site	
Maximum Temperature	74.338 °F
Average Temperature	45.718 °F
Minimum Temperature	33.287 °F
Number of Observations	15,740

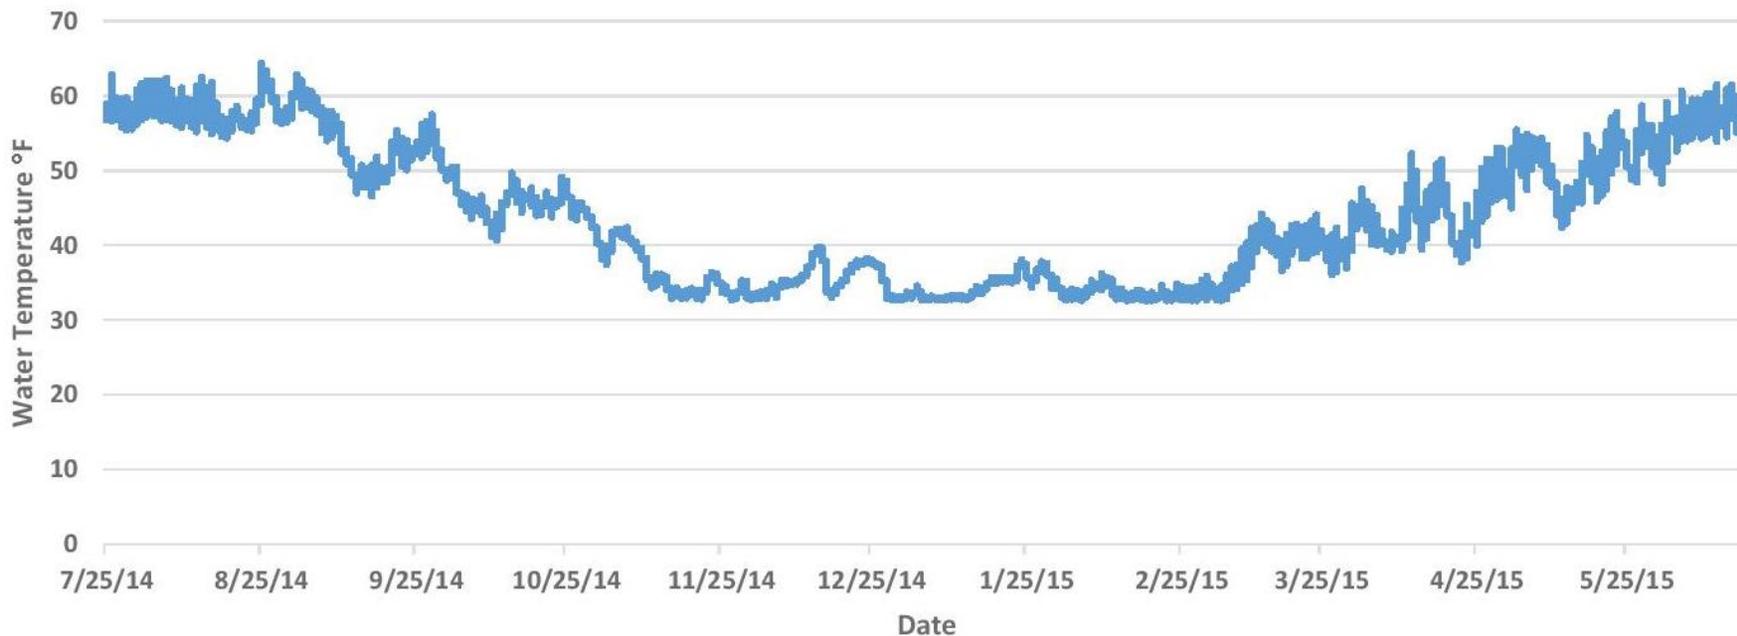
Water Temperature Readings at Stone's Bridge Site

There are no significant outliers at Site 7.

Statistical Summary of Stone's Bridge Site	
Maximum Temperature	64.288 °F
Average Temperature	44.036 °F
Minimum Temperature	32.592 °F
Number of Observations	15,743

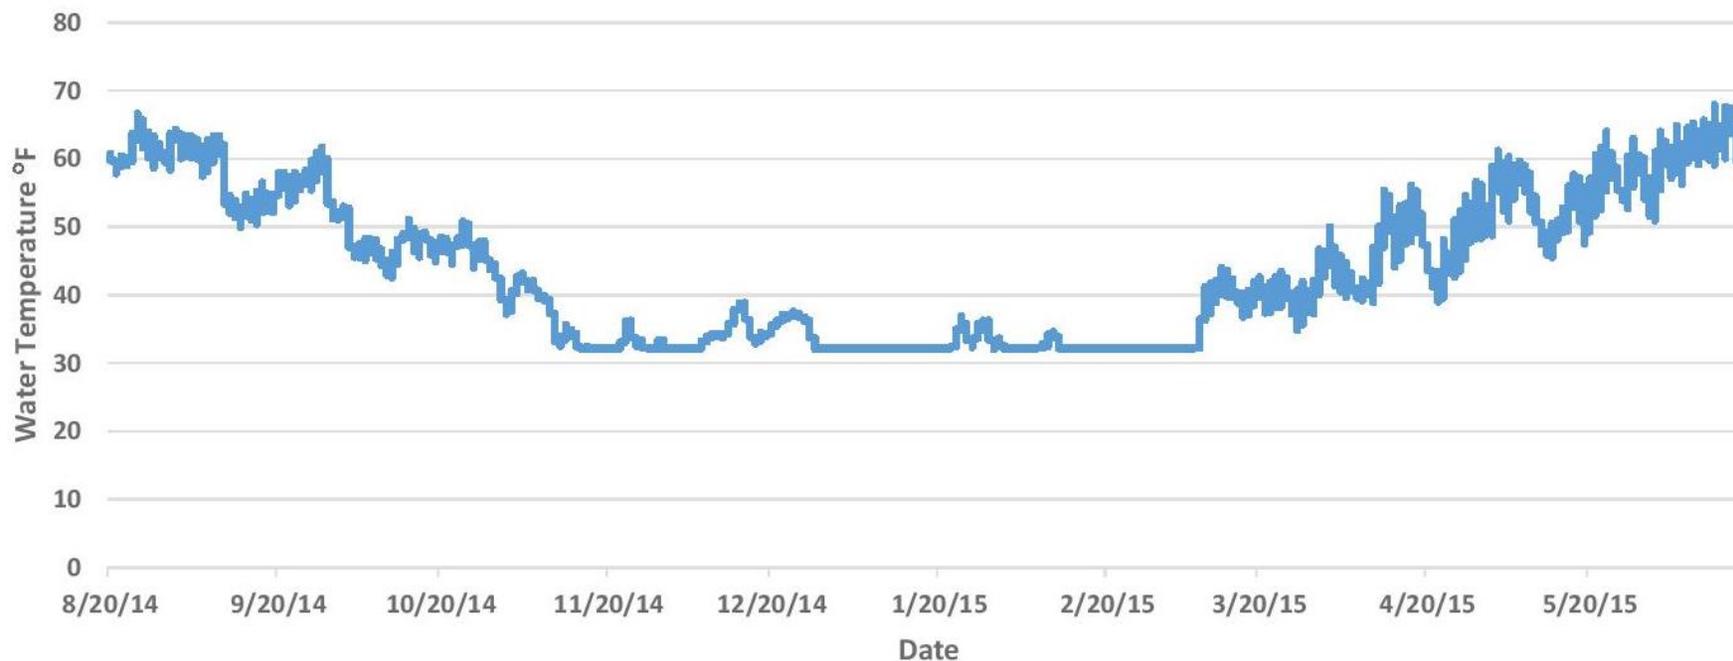
Water Temperature Readings at Brule Ranger Station Site

There are no significant outliers at Site 8. It is important to note the two periods of time where there is absolutely no change in the temperature shown on the graph. Each period of time (December 28th, 2014 – January 22nd, 2015 and February 2nd, 2015 – March 8th, 2015) occurs during cold months, and could possibly be a result of the monitor being frozen in ice. The temperatures recorded during both plateau events are exactly 32.142 °F, the freezing temperature of water.

Statistical Summary of Brule Ranger Station Site	
Maximum Temperature	67.928 °F
Average Temperature	43.855 °F
Minimum Temperature	32.043 °F
Number of Observations	14,490

Site Location | Consideration to relocate the monitor at the Brule Ranger Station should be made. As shown in the data, it appears to have frozen solid. Moving it to a deeper portion of the river may help in avoiding the freezing of the monitor.

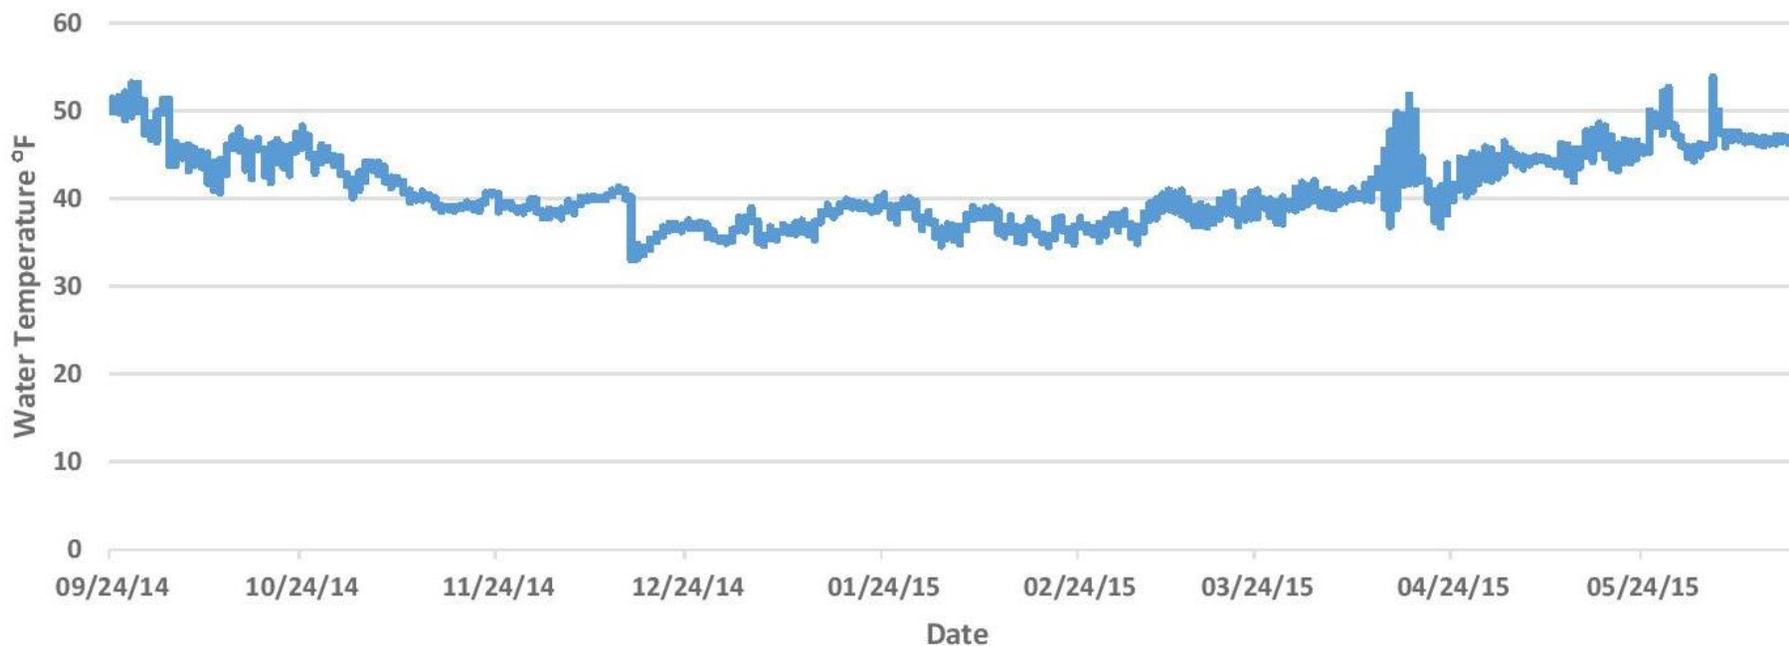
Water Temperature Readings at Castle's Road Culvert Site

There are no significant outliers at Site 9.

Statistical Summary of Castle's Road Culvert Site	
Maximum Temperature	53.82 °F
Average Temperature	41.094 °F
Minimum Temperature	33.039 °F
Number of Observations	12,816

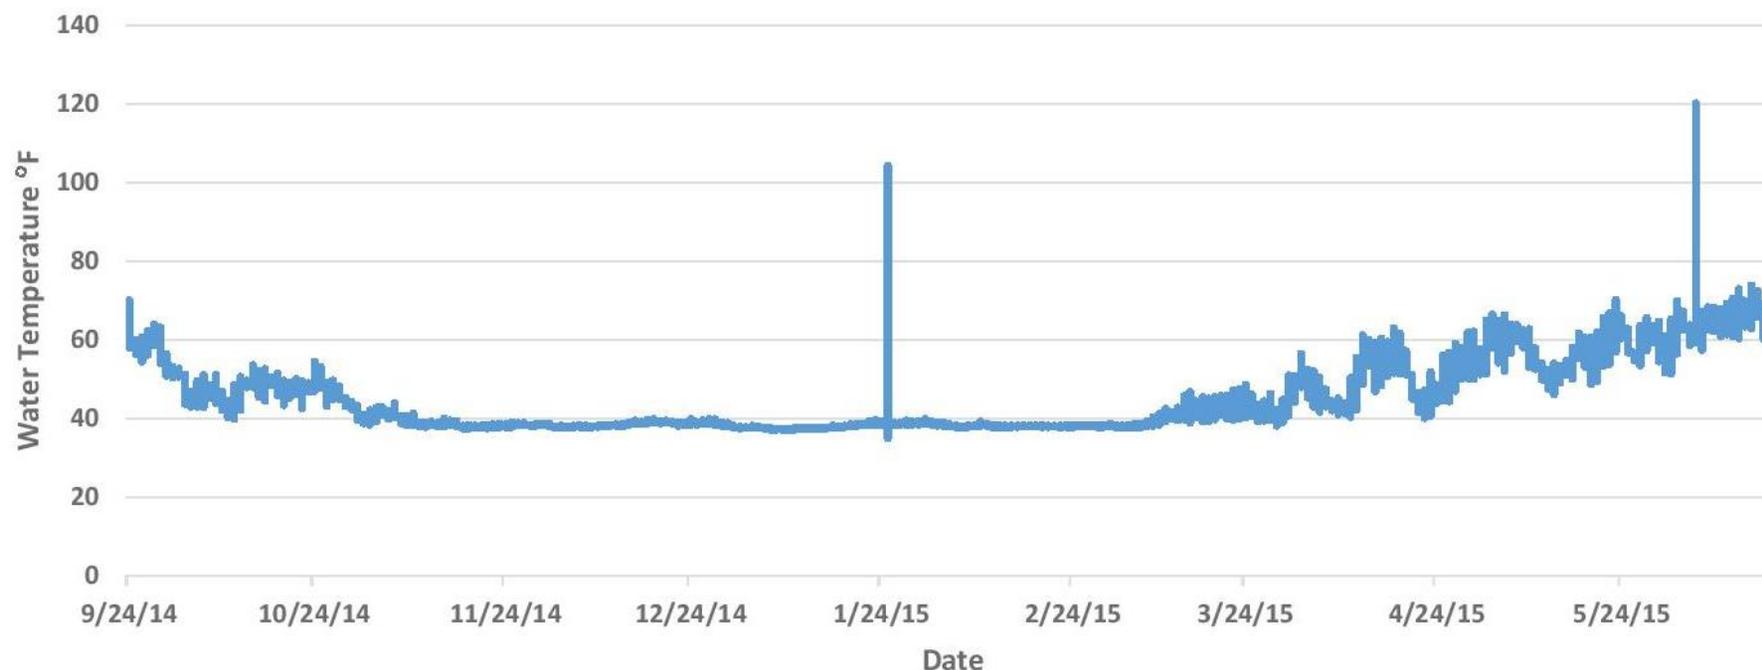
Water Temperature Readings at Jack's Lake Site

The first temperature spike occurs on January 25th, 2015 at 7:55 PM. For 3 recording intervals temperatures over 100°F are observed, immediately afterwards the monitor records normal temperatures of about 38°F. The second spike occurs June 5th, 2015 at 8:25 AM. For 3 recording intervals temperatures of over 120 °F are observed. Afterwards, the monitor resumes recording normal temperatures of about 59°F.

Statistical Summary of Jack's Lake Site	
Maximum Temperature	89.499 °F
Average Temperature	51.518 °F
Minimum Temperature	35.006 °F
Number of Observations	16,937

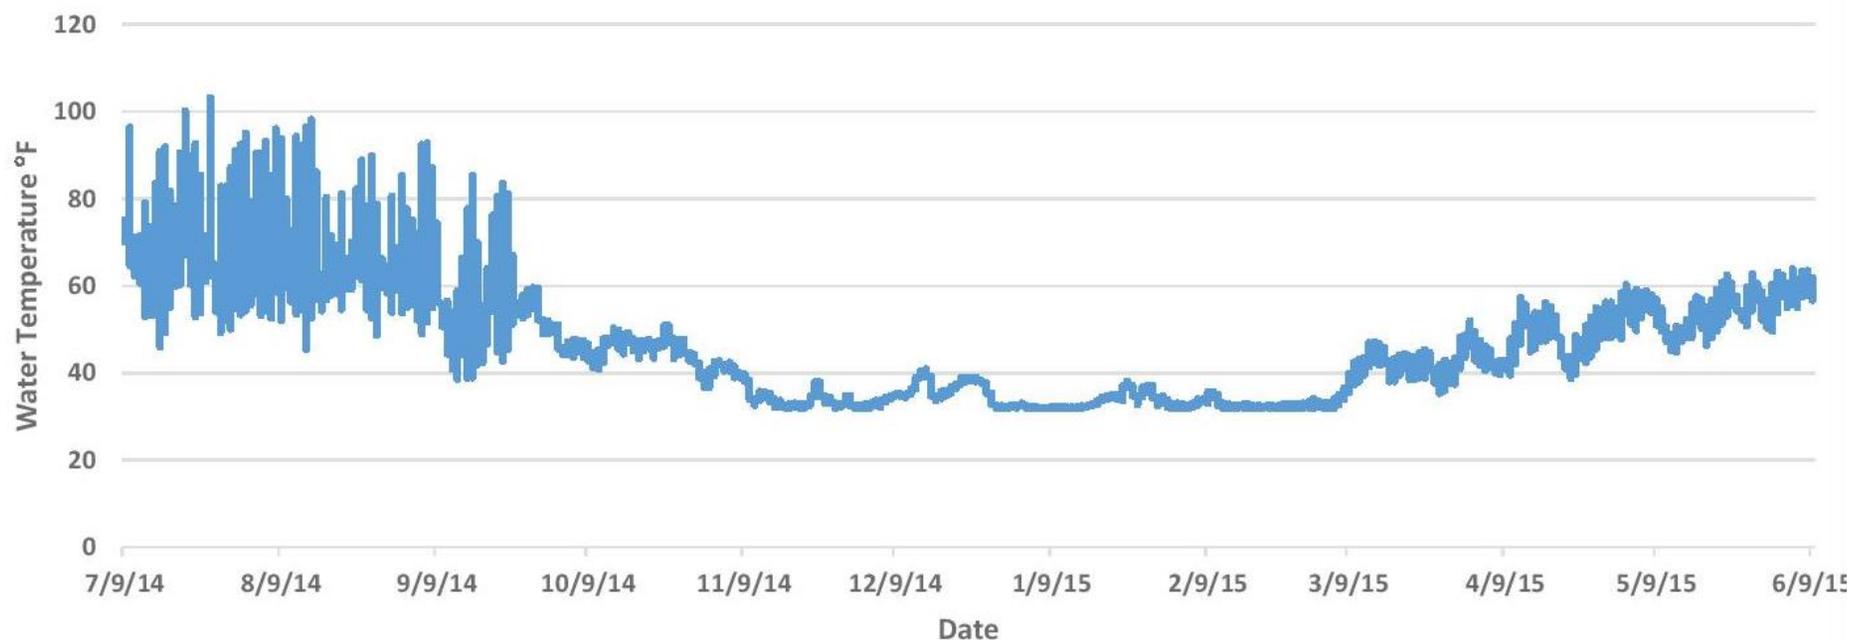
Water Temperature Readings at Noyes' Camp Site

Of all sites monitored, Site 11 shows the most variable data recordings. From its deployment on July 10th, 2014, it records erratic temperatures until early October 2014. The daily cycle appears to be very cool temperatures in the early morning through afternoon, and a sharp increase in temperatures in the evening around 5:00 PM.

Statistical Summary of Noyes' Camp Site	
Maximum Temperature	103.104 °F
Average Temperature	46.443 °F
Minimum Temperature	31.816 °F
Number of Observations	16,088

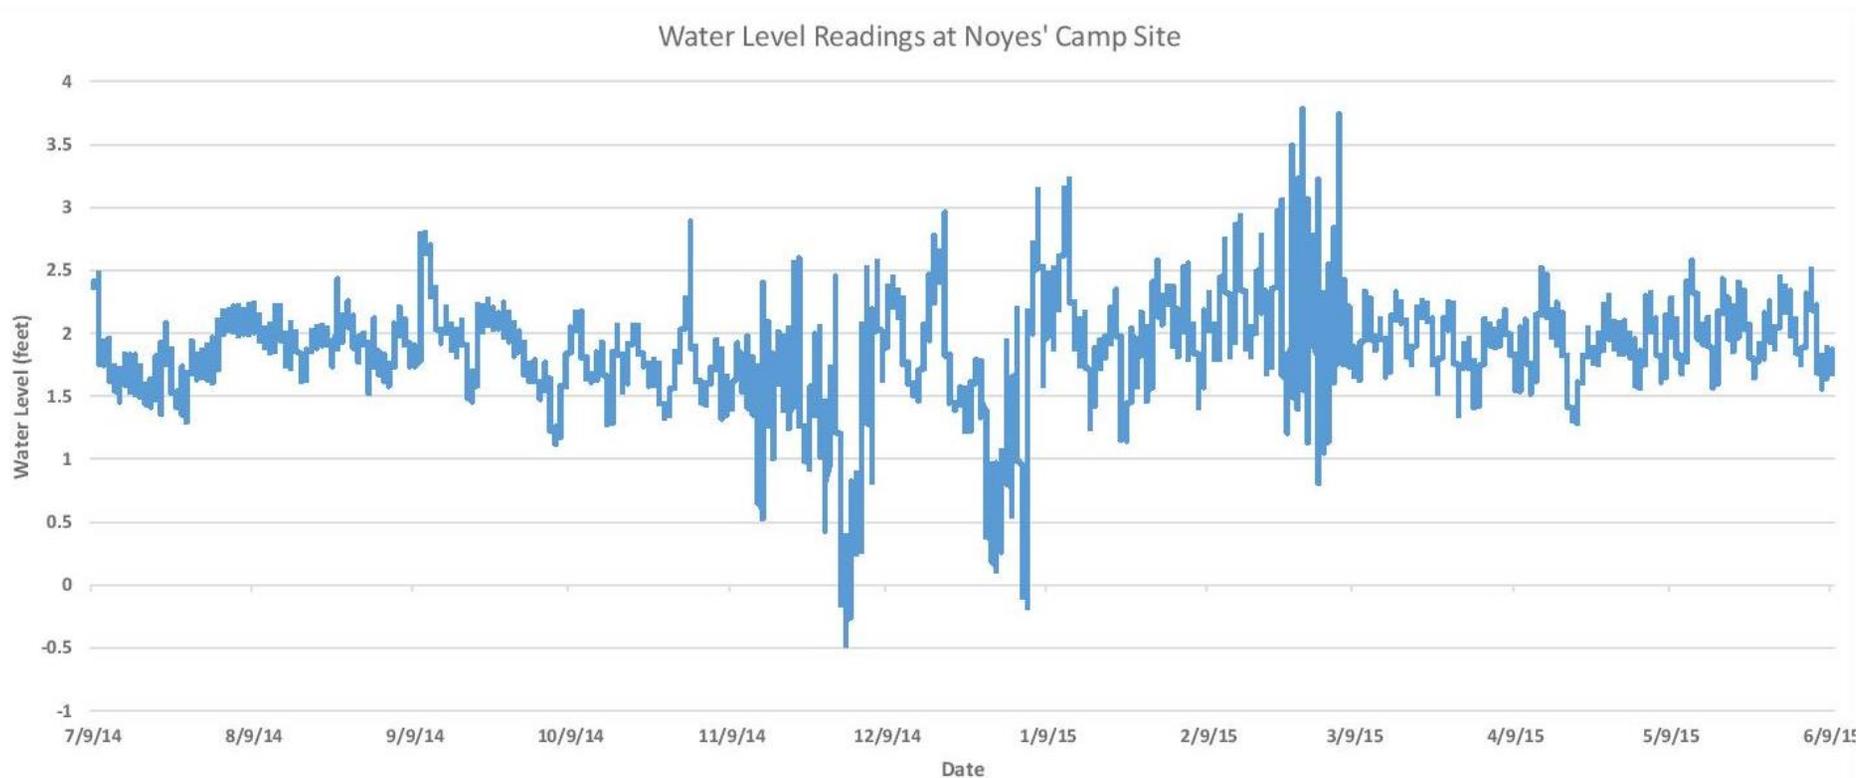
Site 11: Noyes' Camp Dock [Water Level Data]

It is difficult to extrapolate meaningful data from this period. It is recommended that the site be moved to a location within the thalweg of the stream and recalibrate the equipment. Future location considerations and installation of a water level / temperature monitoring site should consult with the manufacturer to assure quality and consistency.
